Sacramento River, RM 77.2L

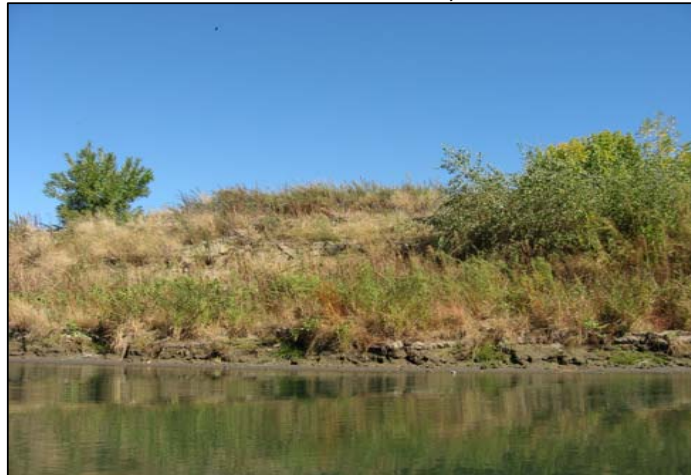
Site Photograph

Criteria	Score	Notes
Bank Slope (*2)	1	2.5:1 slope
Berm Width (*2) - Estimated	0	30 ft
Length of erosion	3	578 ft
Location of erosion	2	full bank
Bank Stability	2	small vertical sections
Radius of Curvature (R_c/w)	3	$R/w = 2.79$
Site Relative to Bend	5	outside of a less than 90 degree bend
Geomorph	0	no migration expected
Vegetation Cover	3	40%
Tree Hazard	1	young trees
Soil Type (*2)	2	clays and silts
Velocity (*2)	3	4.97 ft/s
Wave Action (Wind/Boat)	3	moderate
Economic Factor (*2)	3	Rural town of Colusa
Human Usage	2	seasonal
Seepage Potential	0	no seepage history
Tidal Fluctuation	0	no tidal influence
Erosion Hazard	42	Calculate Erosion Hazard

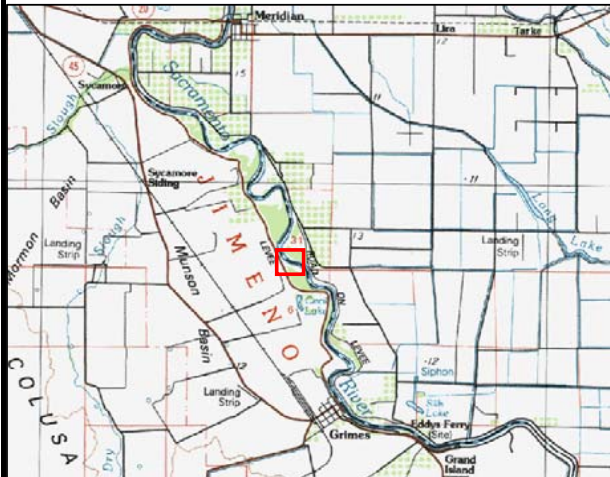
Site Location Map

Sacramento River, RM 127.9R

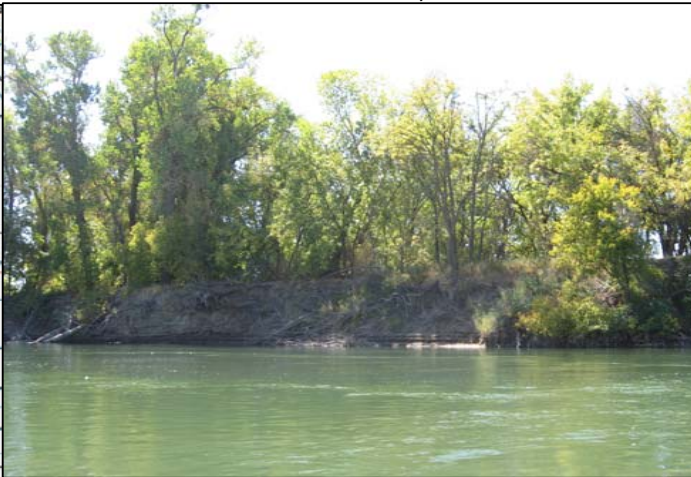
Site Photograph

Criteria	Score	Notes
Bank Slope (*2)	2	2:1 slope
Berm Width (*2) - Estimated	0	35 ft
Length of erosion	2	236 ft
Location of erosion	4	bank and toe
Bank Stability	2	vertical at toe
Radius of Curvature (R_c/w)	1	$R/w = 4.52$
Site Relative to Bend	3	outside of a gentle bend
Geomorph	5	migration possible on both banks
Vegetation Cover	2	40%
Tree Hazard	3	large trees
Soil Type (*2)	2	clays and silts
Velocity (*2)	2	2.92 ft/s
Wave Action (Wind/Boat)	3	moderate
Economic Factor (*2)	2	small town of Grimes
Human Usage	1	occassioanl
Seepage Potential	0	no seepage history
Tidal Fluctuation	0	no tidal influence
Erosion Hazard	42	Calculate Erosion Hazard

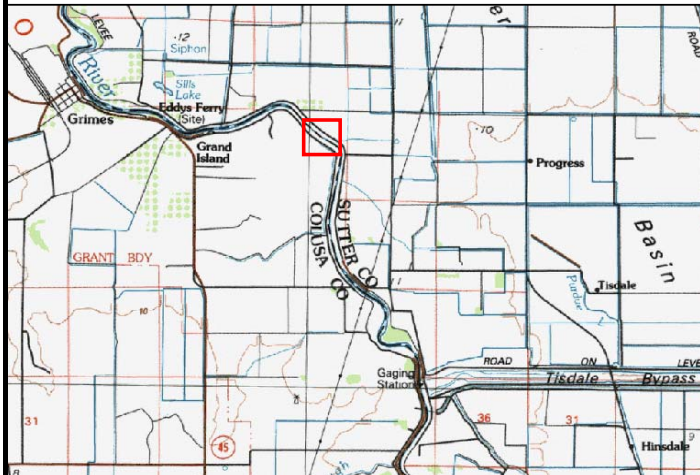
Site Location Map

Sacramento River, RM 122.3R

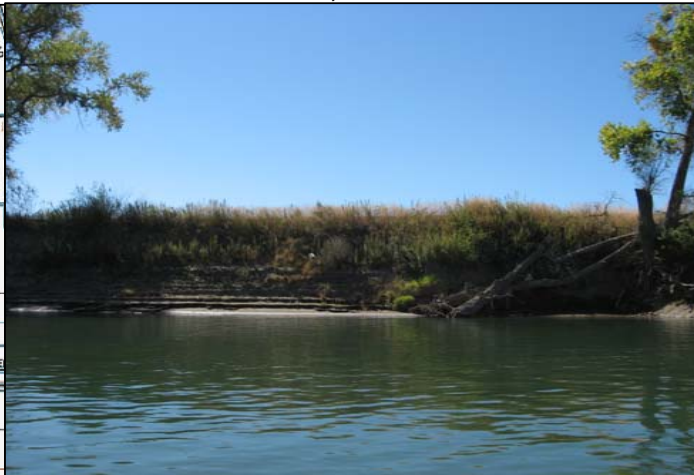
Site Photograph

Criteria	Score	Notes
Bank Slope (*2)	3	1.5:1 slope
Berm Width (*2) - Estimated	0	40 ft
Length of erosion	2	238 ft
Location of erosion	4	bank and toe
Bank Stability	2	short vertical sections
Radius of Curvature (R_c/w)	0	straight
Site Relative to Bend	1	straight
Geomorph	0	no migration possible
Vegetation Cover	2	40 - 50%
Tree Hazard	4	large trees, exposed roots
Soil Type (*2)	2	clays and silts
Velocity (*2)	4	5.48 ft/s
Wave Action (Wind/Boat)	2	moderate
Economic Factor (*2)	2	small town of Grimes
Human Usage	3	monthly
Seepage Potential	0	no seepage history
Tidal Fluctuation	0	no tidal influence
Erosion Hazard	42	Calculate Erosion Hazard

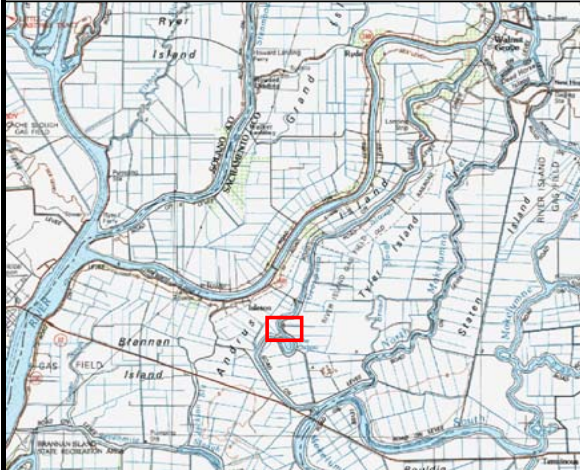
Site Location Map

Georgiana Slough, RM 3.7L (a)

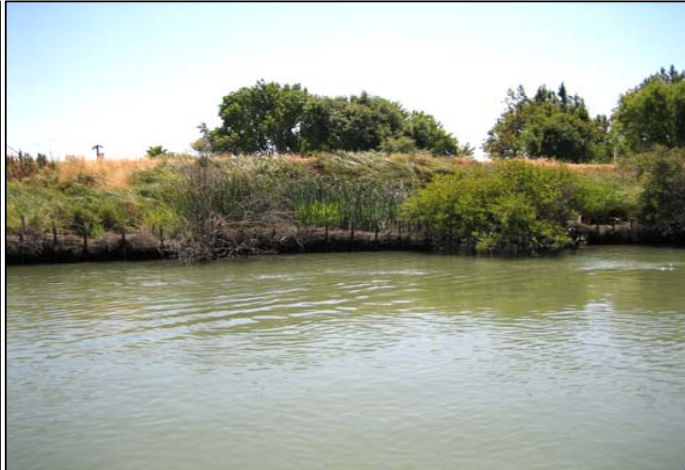
Site Photograph

Criteria	Score	Notes
Bank Slope (*2)	2	2:1 slope
Berm Width (*2) - Estimated	4	less than 5 ft
Length of erosion	1	30 ft
Location of erosion	2	levee slope
Bank Stability	1	erosion pockets
Radius of Curvature (R_c/w)	0	$R/w = 6.59$
Site Relative to Bend	0	inside of a bend
Geomorph	2	cutoff potential on opposite bank
Vegetation Cover	0	90% cover
Tree Hazard	0	no trees
Soil Type (*2)	4	sands and silts
Velocity (*2)	3	4.04 ft/s
Wave Action (Wind/Boat)	3	moderate boat wake
Economic Factor (*2)	1	Farms
Human Usage	1	occasional
Seepage Potential	0	no seepage history
Tidal Fluctuation	4	4 ft of tidal flux
Erosion Hazard	42	Calculate Erosion Hazard

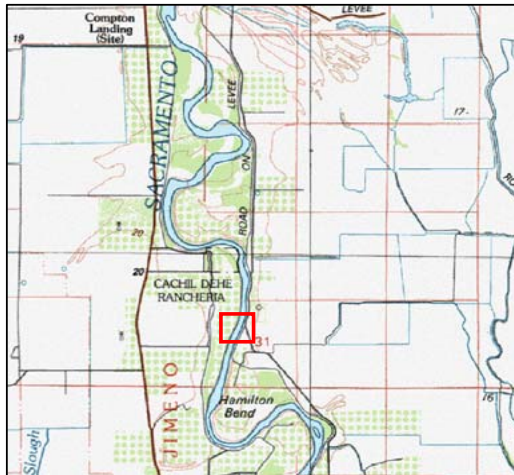
Site Location Map

Sacramento River, RM 152.8L

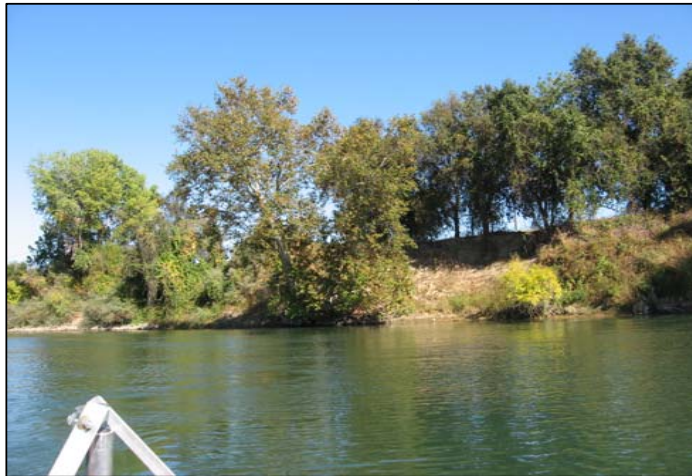
Site Photograph

Criteria	Score	Notes
Bank Slope (*2)	3	1.5:1 slope
Berm Width (*2) - Estimated	0	30 ft
Length of erosion	2	248 ft
Location of erosion	2	full bank
Bank Stability	5	vertical sections and caves
Radius of Curvature (R_c/w)	0	straight
Site Relative to Bend	1	straight
Geomorph	2	migration possible on opposite bank
Vegetation Cover	1	70%
Tree Hazard	5	large trees, leaning with exposed roots
Soil Type (*2)	2	clays and silts
Velocity (*2)	3	4.64 ft/s
Wave Action (Wind/Boat)	3	moderate
Economic Factor (*2)	1	Farms
Human Usage	2	seasonal
Seepage Potential	0	no seepage history
Tidal Fluctuation	0	no tidal influence
Erosion Hazard	41	Calculate Erosion Hazard

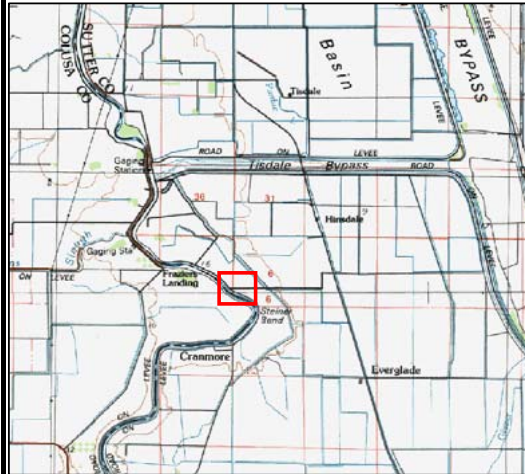
Site Location Map

Sacramento River, RM 116.0L

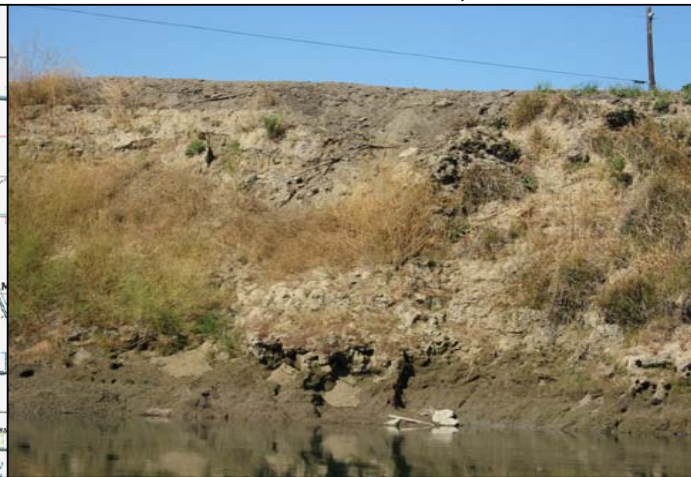
Site Photograph

Criteria	Score	Notes
Bank Slope (*2)	3	1.5:1 slope
Berm Width (*2) - Estimated	0	30 ft
Length of erosion	3	904 ft
Location of erosion	3	toe
Bank Stability	1	animal burrows
Radius of Curvature (R_c/w)	2	$R/w = 3.37$
Site Relative to Bend	5	outside of a tight bend
Geomorph	0	no migration expected
Vegetation Cover	1	70%
Tree Hazard	0	no trees
Soil Type (*2)	4	sands and silts
Velocity (*2)	3	3.38 ft/s
Wave Action (Wind/Boat)	2	moderate
Economic Factor (*2)	1	Farms
Human Usage	2	seasonal
Seepage Potential	0	no seepage history
Tidal Fluctuation	0	no tidal influence
Erosion Hazard	41	Calculate Erosion Hazard

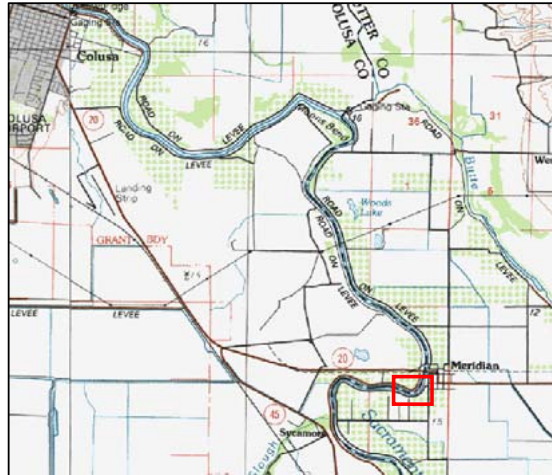
Site Location Map

Sacramento River, RM 133.8L

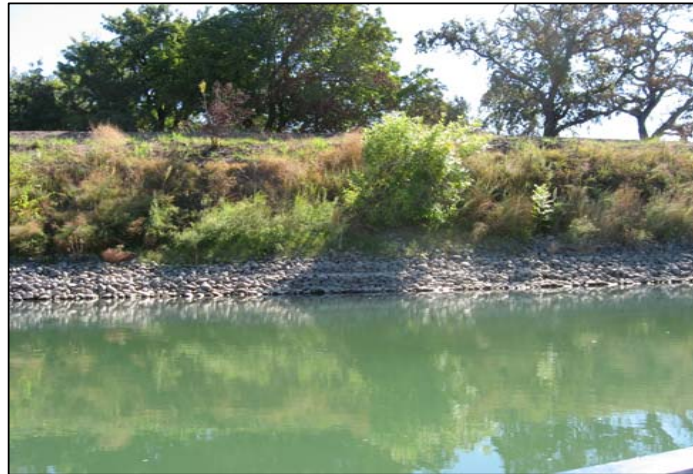
Site Photograph

Criteria	Score	Notes
Bank Slope (*2)	3	1.5:1 slope
Berm Width (*2) - Estimated	1	more than 20 ft of berm
Length of erosion	2	199 ft
Location of erosion	2	lower bank
Bank Stability	2	vertical sections less than half bank height
Radius of Curvature (R_c/w)	4	$R/w = 1.61$
Site Relative to Bend	4	outside of a 90 degree bend
Geomorph	0	no migration expected
Vegetation Cover	1	80%
Tree Hazard	0	no trees
Soil Type (*2)	1	clays and rounded stone
Velocity (*2)	3	4.9 ft/s
Wave Action (Wind/Boat)	3	moderate
Economic Factor (*2)	2	small town of Meridian
Human Usage	2	adjacent to town, seasonal
Seepage Potential	0	no seepage history
Tidal Fluctuation	0	no tidal influence
Erosion Hazard	40	Calculate Erosion Hazard

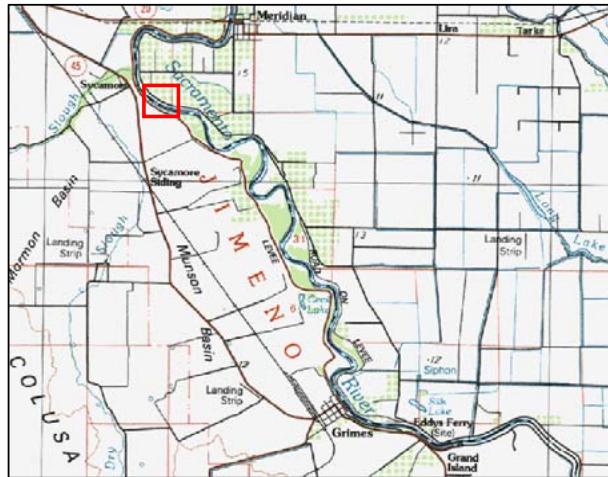
Site Location Map

Sacramento River, RM 131.8L

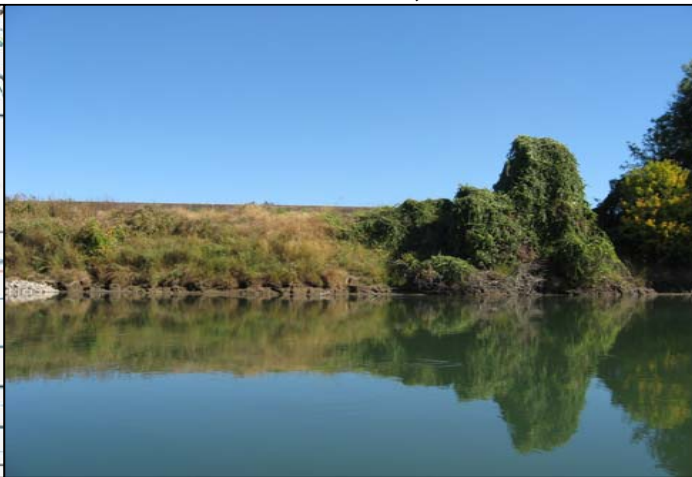
Site Photograph

Criteria	Score	Notes
Bank Slope (*2)	2	2:1 slope
Berm Width (*2) - Estimated	1	25 ft
Length of erosion	2	140 ft
Location of erosion	3	toe
Bank Stability	1	caves
Radius of Curvature (R_c/w)	0	$R/w = 12$
Site Relative to Bend	2	just downstream of a bend
Geomorph	0	no migration expected
Vegetation Cover	3	40%
Tree Hazard	3	large trees
Soil Type (*2)	2	clays and silts
Velocity (*2)	4	5.04 ft/s
Wave Action (Wind/Boat)	2	moderate
Economic Factor (*2)	2	small town of Meridian
Human Usage	2	seasonal
Seepage Potential	0	no seepage history
Tidal Fluctuation	0	no tidal influence
Erosion Hazard	40	Calculate Erosion Hazard

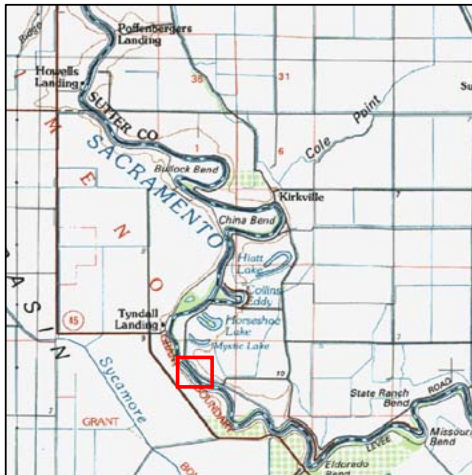
Site Location Map

Sacramento River, RM 101.3R

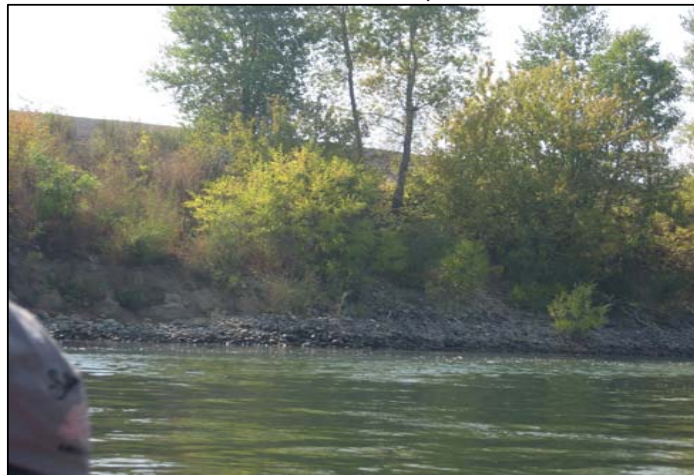
Site Photograph

Criteria	Score	Notes
Bank Slope (*2)	4	1:1 slope
Berm Width (*2) - Estimated	2	greater than 10 ft
Length of erosion	2	188 ft
Location of erosion	3	toe
Bank Stability	5	caves less than 4 ft and some vertical sections
Radius of Curvature (R_c/w)	0	straight
Site Relative to Bend	1	straight
Geomorph	0	no migration expected
Vegetation Cover	2	50%
Tree Hazard	0	small trees
Soil Type (*2)	2	clays and silts
Velocity (*2)	3	3.22 ft/s
Wave Action (Wind/Boat)	2	moderate
Economic Factor (*2)	1	Farms
Human Usage	1	occassional
Seepage Potential	0	no seepage history
Tidal Fluctuation	0	no tidal influence
Erosion Hazard	40	Calculate Erosion Hazard

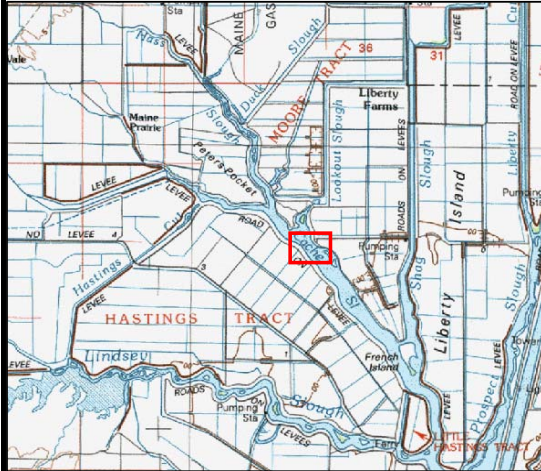
Site Location Map

Cache Slough, RM 22.8R

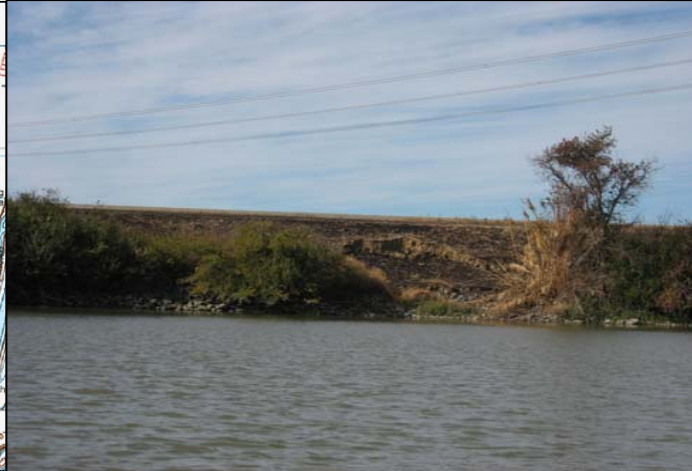
Site Photograph

Criteria	Score	Notes
Bank Slope (*2)	1	2.5:1 slope
Berm Width (*2) - Estimated	5	no berm
Length of erosion	1	100 ft
Location of erosion	4	mid-lower bank and toe
Bank Stability	2	vertical sections, less than half bank height
Radius of Curvature (R_c/w)	0	straight
Site Relative to Bend	1	straight
Geomorph	0	no migration expected
Vegetation Cover	2	40%
Tree Hazard	0	small trees
Soil Type (*2)	2	clays and silts
Velocity (*2)	0	less than a 1ft/s
Wave Action (Wind/Boat)	4	heavy wind
Economic Factor (*2)	1	Farms
Human Usage	4	weekly, human debris and path
Seepage Potential	0	no known seepage history
Tidal Fluctuation	4	roughly 4 ft of tidal flux
Erosion Hazard	40	Calculate Erosion Hazard

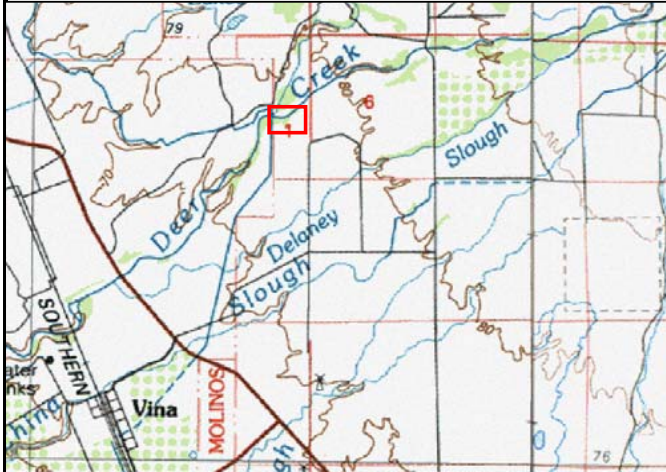
Site Location Map

Deer Creek, LM 2.4 (Tehama County Unit 1 South)

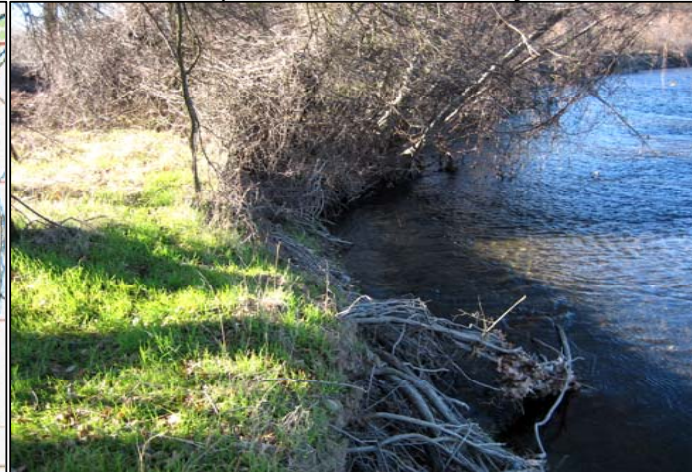
Site Photograph

Criteria	Score	Notes
Bank Slope (*2)	2	2:1 slope
Berm Width (*2) - Estimated	2	10 to 15 ft
Length of erosion	1	100 ft
Location of erosion	4	whole bank
Bank Stability	0	no vertical sections or caves
Radius of Curvature (R_c/w)	2	$R/w = 3.58$
Site Relative to Bend	3	outside of a gentle bend
Geomorph	0	no migration expected
Vegetation Cover	1	80%
Tree Hazard	5	trees leaning, about to fall, roots exposed
Soil Type (*2)	3	sands and cobbles
Velocity (*2)	2	3 ft/s
Wave Action (Wind/Boat)	0	no waves
Economic Factor (*2)	2	small town of Vina
Human Usage	2	seasonal
Seepage Potential	0	no known seepage history
Tidal Fluctuation	0	not tidal
Erosion Hazard	40	Calculate Erosion Hazard

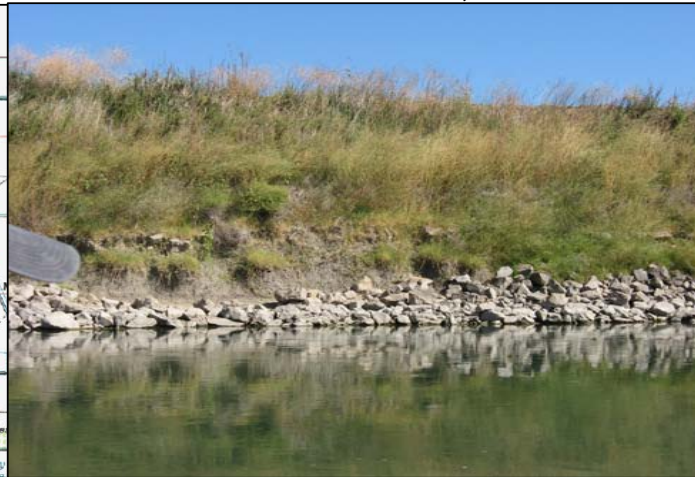
Site Photograph

Sacramento River, RM 99.0L

Criteria	Score	Notes
Bank Slope (*2)	4	1:1 slope
Berm Width (*2) - Estimated	2	10 ft
Length of erosion	5	1620 ft
Location of erosion	1	levee slope
Bank Stability	0	no vertical sections or caves
Radius of Curvature (R_c/w)	0	$R/w = 6.4$
Site Relative to Bend	3	outside of a gentle bend
Geomorph	0	no migration expected
Vegetation Cover	1	60%
Tree Hazard	0	no trees
Soil Type (*2)	4	sands and silts
Velocity (*2)	2	2.72 ft/s
Wave Action (Wind/Boat)	2	moderate
Economic Factor (*2)	1	Farms
Human Usage	1	occassional
Seepage Potential	0	no seepage history
Tidal Fluctuation	0	no tidal influence
Erosion Hazard	39	Calculate Erosion Hazard

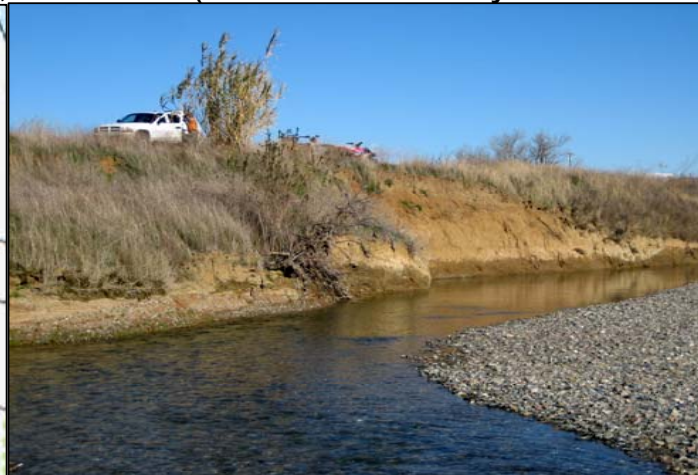
Site Photograph

Elder Creek, LM 1.44 (Tehama County Unit 1 North)

Criteria	Score	Notes
Bank Slope (*2)	4	less than 1:1 slope
Berm Width (*2) - Estimated	1	25 to 30 ft
Length of erosion	2	330 ft
Location of erosion	5	whole bank and underwater
Bank Stability	5	vertical sections and animal burrows
Radius of Curvature (R_c/w)	0	straight
Site Relative to Bend	1	straight
Geomorph	0	no migration expected
Vegetation Cover	2	60%
Tree Hazard	0	no trees
Soil Type (*2)	2	clays and silts
Velocity (*2)	2	3 ft/s
Wave Action (Wind/Boat)	0	no waves
Economic Factor (*2)	2	small town of Gerber
Human Usage	2	seasonal
Seepage Potential	0	no known seepage history
Tidal Fluctuation	0	not tidal

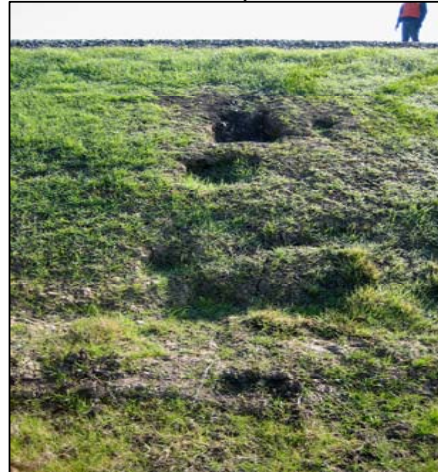
Site Photograph

Cherokee Canal, LM 14.0 (DWR MA13 Unit 2 East)

Criteria	Score	Notes
Bank Slope (*2)	1	2.5:1 slope
Berm Width (*2) - Estimated	5	no berm
Length of erosion	2	185 ft
Location of erosion	4	toe and lower slope
Bank Stability	3	Piping holes greater than 4 ft
Radius of Curvature (R_c/w)	0	relatively straight
Site Relative to Bend	3	outside of slight bend
Geomorph	0	no migration expected
Vegetation Cover	0	grass covers 80 to 90%
Tree Hazard	0	no trees
Soil Type (*2)	2	silts and clays
Velocity (*2)	3	4 ft/s
Wave Action (Wind/Boat)	0	none
Economic Factor (*2)	2	small town of Biggs
Human Usage	1	occassional
Seepage Potential	0	no known seepage history
Tidal Fluctuation	0	not tidal

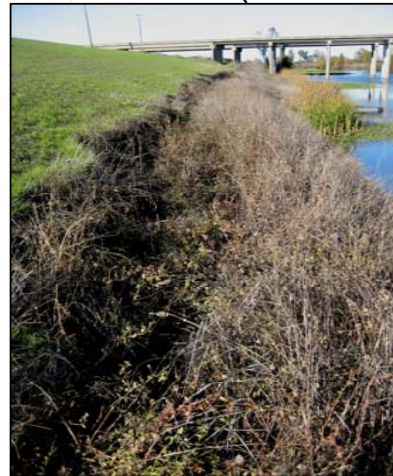
Site Photograph

Yolo Bypass, LM 0.1 (RD 2035 Unit 2 West)

Criteria	Score	Notes
Bank Slope (*2)	0	3:1 slope
Berm Width (*2) - Estimated	5	no berm
Length of erosion	2	425 ft
Location of erosion	4	toe and lower slope
Bank Stability	2	vertical sections, less than half bank height
Radius of Curvature (R_c/w)	0	straight
Site Relative to Bend	1	straight
Geomorph	0	no migration expected
Vegetation Cover	1	70%
Tree Hazard	0	no trees
Soil Type (*2)	2	clays and silts
Velocity (*2)	1	1.5 ft/s
Wave Action (Wind/Boat)	4	Heavy wind waves
Economic Factor (*2)	4	City of Woodland
Human Usage	1	occassional
Seepage Potential	0	no known seepage history
Tidal Fluctuation	0	no tidal influence

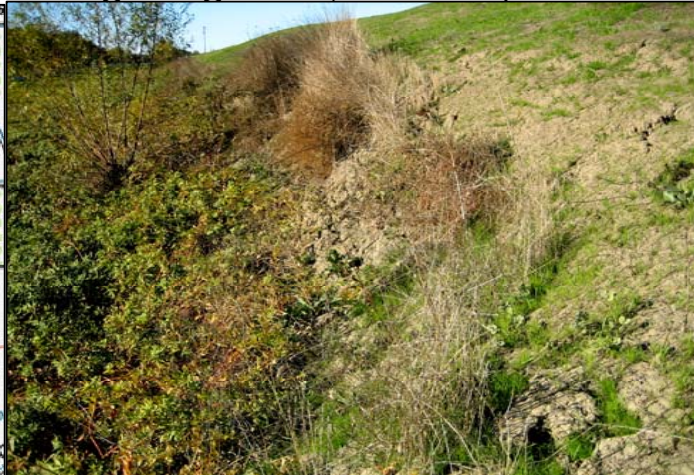
Site Photograph

Knights Landing Ridge Cut, LM 5.3 (KLRD Unit 2 East)

Criteria	Score	Notes
Bank Slope (*2)	2	2:1 slope
Berm Width (*2) - Estimated	5	0 to 5 ft of berm
Length of erosion	5	8500 ft of erosion
Location of erosion	4	toe and lower slope
Bank Stability	2	6 to 8 ft of vertical slope in sections
Radius of Curvature (R_c/w)	0	straight
Site Relative to Bend	1	straight
Geomorph	0	no migration possible
Vegetation Cover	1	burned annually, 70%
Tree Hazard	1	small trees
Soil Type (*2)	2	clays and silts
Velocity (*2)	0	0.08 ft/s
Wave Action (Wind/Boat)	1	occasional wave
Economic Factor (*2)	2	town of Knights Landing
Human Usage	1	occasional, no access but close to town
Seepage Potential	0	no seepage history
Tidal Fluctuation	0	not tidal influence

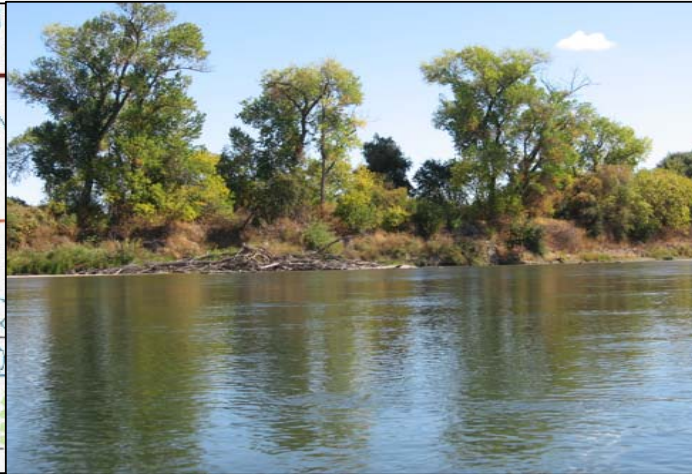
Site Photograph

Sacramento River, RM 168.3L

Criteria	Score	Notes
Bank Slope (*2)	1	2.5:1 slope
Berm Width (*2) - Estimated	0	30 ft
Length of erosion	3	522 ft
Location of erosion	3	toe
Bank Stability	0	no vertical sections or caves
Radius of Curvature (R_c/w)	0	straight
Site Relative to Bend	1	straight
Geomorph	2	migration possible on opposite bank
Vegetation Cover	1	60 to 70%
Tree Hazard	3	large trees
Soil Type (*2)	4	sand and silts (sand deposited)
Velocity (*2)	3	4.81 ft/s
Wave Action (Wind/Boat)	2	low
Economic Factor (*2)	2	small town of Butte City
Human Usage	2	seasonal
Seepage Potential	0	no seepage history
Tidal Fluctuation	0	no tidal influence
Erosion Hazard	37	Calculate Erosion Hazard

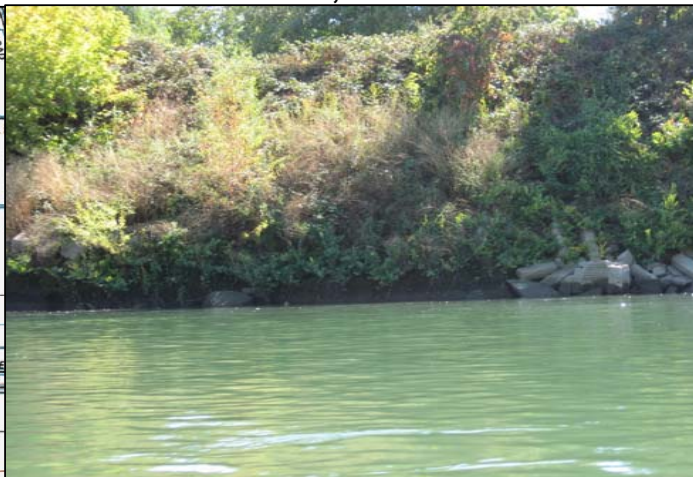
Site Photograph

Sacramento River, RM 123.7R

Criteria	Score	Notes
Bank Slope (*2)	4	1:1 slope
Berm Width (*2) - Estimated	2	15 ft
Length of erosion	2	130 ft
Location of erosion	3	toe
Bank Stability	0	no vertical sections or caves
Radius of Curvature (R_c/w)	0	straight
Site Relative to Bend	2	just downstream from a bend
Geomorph	0	no migration possible
Vegetation Cover	0	80 to 90%
Tree Hazard	0	no trees
Soil Type (*2)	2	clays and silts
Velocity (*2)	4	5.3 ft/s
Wave Action (Wind/Boat)	2	moderate
Economic Factor (*2)	2	small town of Grimes
Human Usage	0	rare
Seepage Potential	0	no seepage history
Tidal Fluctuation	0	no tidal influence

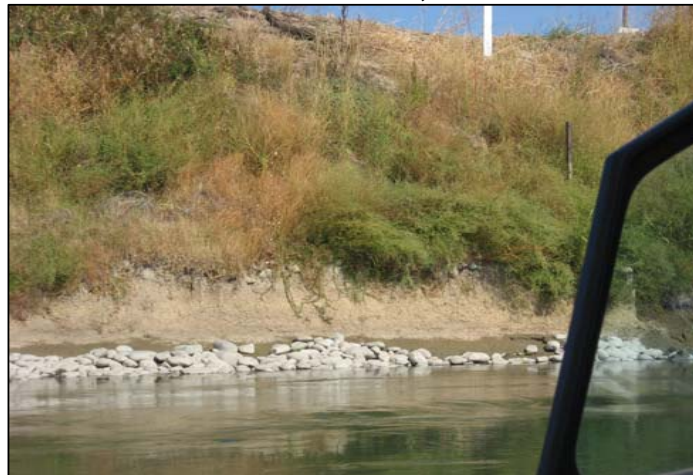
Site Photograph

Sacramento River, RM 104.5L

Criteria	Score	Notes
Bank Slope (*2)	3	1.5:1 slope
Berm Width (*2) - Estimated	0	40 ft
Length of erosion	4	1158 ft
Location of erosion	4	berm and toe
Bank Stability	0	no vertical sections or caves
Radius of Curvature (R_c/w)	1	$R/w = 4.84$
Site Relative to Bend	4	outside of a 90 degree bend
Geomorph	2	migration possible on opposite bank
Vegetation Cover	1	70%
Tree Hazard	0	no trees
Soil Type (*2)	4	sands and silts
Velocity (*2)	1	1.68 ft/s
Wave Action (Wind/Boat)	2	moderate
Economic Factor (*2)	1	Farms
Human Usage	1	occassional
Seepage Potential	0	no seepage history
Tidal Fluctuation	0	no tidal influence
Erosion Hazard	37	Calculate Erosion Hazard

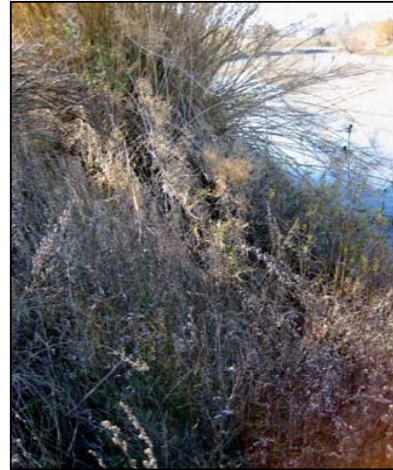
Site Photograph

Elder Creek, LM 3.0 (Tehama County Unit 2 South)

Criteria	Score	Notes
Bank Slope (*2)	3	1.5:1 slope
Berm Width (*2) - Estimated	1	25 to 30 ft
Length of erosion	2	130 ft
Location of erosion	4	whole bank
Bank Stability	0	no holes or vertical sections
Radius of Curvature (R_c/w)	4	$R/w = 1.93$
Site Relative to Bend	5	outside of a tight bend
Geomorph	0	tight levees, no migration expected
Vegetation Cover	0	80%
Tree Hazard	0	small trees
Soil Type (*2)	2	clays and silts
Velocity (*2)	2	3 ft/s
Wave Action (Wind/Boat)	0	no waves
Economic Factor (*2)	2	small town of Gerber
Human Usage	2	seasonal
Seepage Potential	0	no known seepage history
Tidal Fluctuation	0	no tidal flux

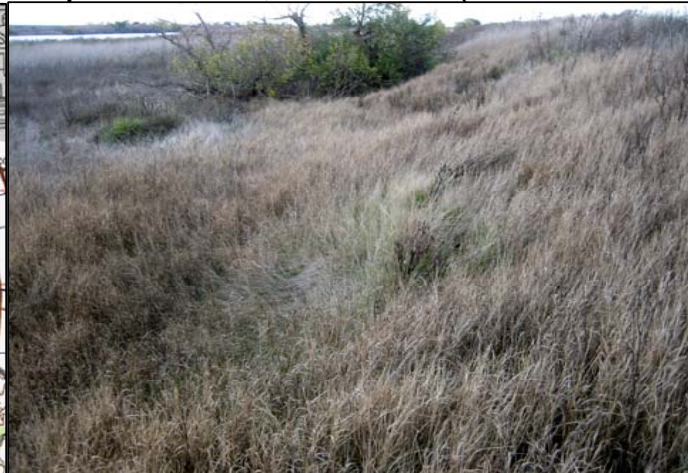
Site Photograph

Deep Water Ship Channel, LM 5.01 (RD 999 Unit 1 East)

Criteria	Score	Notes
Bank Slope (*2)	2	2:1 slope
Berm Width (*2) - Estimated	5	no berm
Length of erosion	1	15 ft
Location of erosion	1	levee slope
Bank Stability	0	no vertical sections or caves
Radius of Curvature (R_c/w)	0	straight
Site Relative to Bend	1	straight
Geomorph	0	no migration possible
Vegetation Cover	1	lots of grass, some shrubs, 80%
Tree Hazard	2	medium tree
Soil Type (*2)	2	clays and silts
Velocity (*2)	1	1.3 ft/s
Wave Action (Wind/Boat)	5	Cargo Ships
Economic Factor (*2)	2	small town of Clarksburg
Human Usage	0	rare
Seepage Potential	0	no known seepage history
Tidal Fluctuation	2	about 2 ft of tidal flux

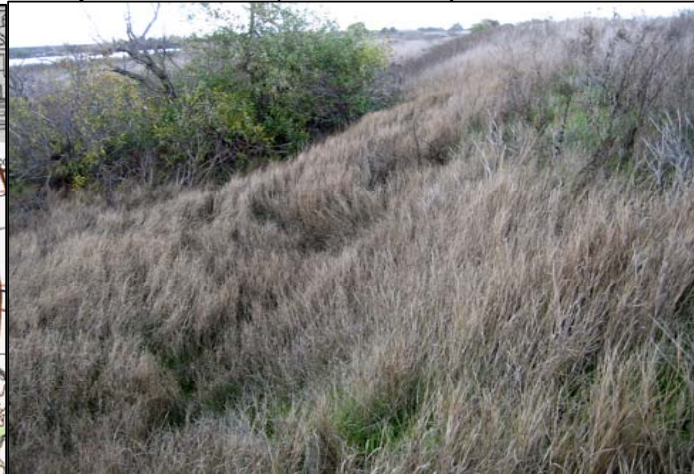
Site Photograph

Deep Water Ship Channel, LM 5.0 (RD 999 Unit 1 East)

Criteria	Score	Notes
Bank Slope (*2)	2	2:1 slope
Berm Width (*2) - Estimated	5	no berm
Length of erosion	1	25 ft
Location of erosion	1	levee slope
Bank Stability	0	no bvertical sections or caves
Radius of Curvature (R_c/w)	0	straight
Site Relative to Bend	1	straight
Geomorph	0	no migration possible
Vegetation Cover	1	lots of grass, some shrubs, 80%
Tree Hazard	2	medium tree
Soil Type (*2)	2	clays and silts
Velocity (*2)	1	1.3 ft/s
Wave Action (Wind/Boat)	5	Cargo Ships
Economic Factor (*2)	2	small town of Clarksburg
Human Usage	0	rare
Seepage Potential	0	no known seepage history
Tidal Fluctuation	2	about 2 ft of tidal flux

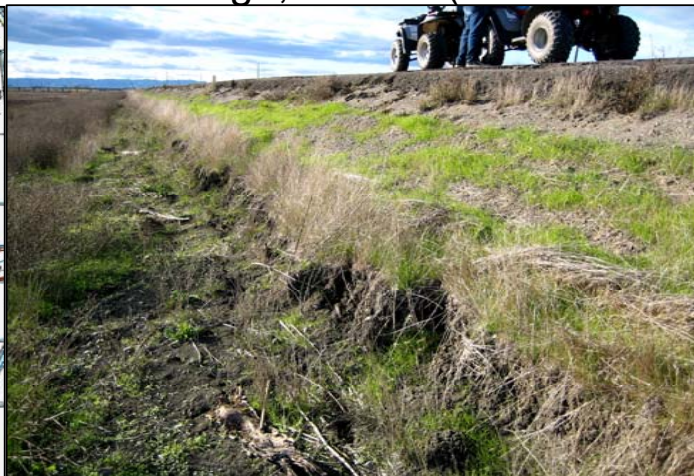
Site Photograph

Willow Slough, LM 0.6 (DWR Unit 1 North)

Criteria	Score	Notes
Bank Slope (*2)	3	1.5:1 slope
Berm Width (*2) - Estimated	5	no berm
Length of erosion	5	2000 ft of erosion
Location of erosion	0	upper levee slope
Bank Stability	2	short vertical sections
Radius of Curvature (R_c/w)	0	straight
Site Relative to Bend	1	straight
Geomorph	0	no migration expected
Vegetation Cover	2	50%
Tree Hazard	0	no trees
Soil Type (*2)	2	clays and silts
Velocity (*2)	0	0.5 ft/s
Wave Action (Wind/Boat)	3	moderate waves
Economic Factor (*2)	1	Farms
Human Usage	2	seasonal for duck hunting
Seepage Potential	0	no known seepage issues
Tidal Fluctuation	0	no tidal influence

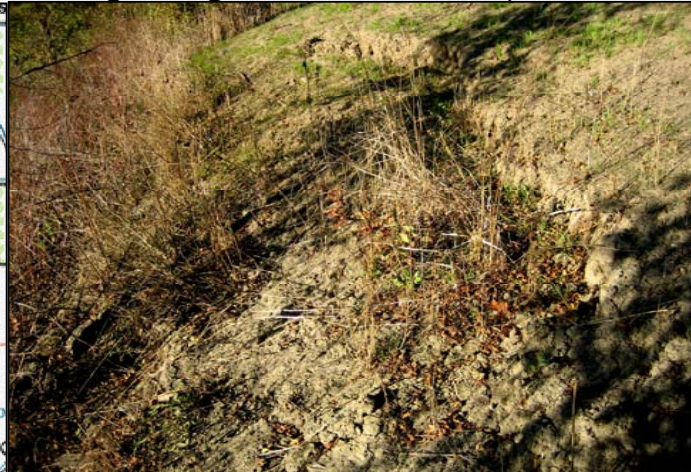
Site Photograph

Knights Landing Ridge Cut, LM 4.3 (KLRD Unit 2 East)

Criteria	Score	Notes
Bank Slope (*2)	2	2:1 slope
Berm Width (*2) - Estimated	5	no berm
Length of erosion	2	350 ft
Location of erosion	4	toe and lower slope
Bank Stability	2	vertical sections, less than half bank height
Radius of Curvature (R_c/w)	0	relatively straight
Site Relative to Bend	1	relatively straight
Geomorph	0	no migration possible
Vegetation Cover	2	50 to 60%
Tree Hazard	1	young trees
Soil Type (*2)	2	silts with some clay
Velocity (*2)	0	0.09 ft/s
Wave Action (Wind/Boat)	1	occassional wave
Economic Factor (*2)	2	town of Knights Landing
Human Usage	1	occassional, no access but close to town
Seepage Potential	0	no known seepage history
Tidal Fluctuation	0	no tidal influence

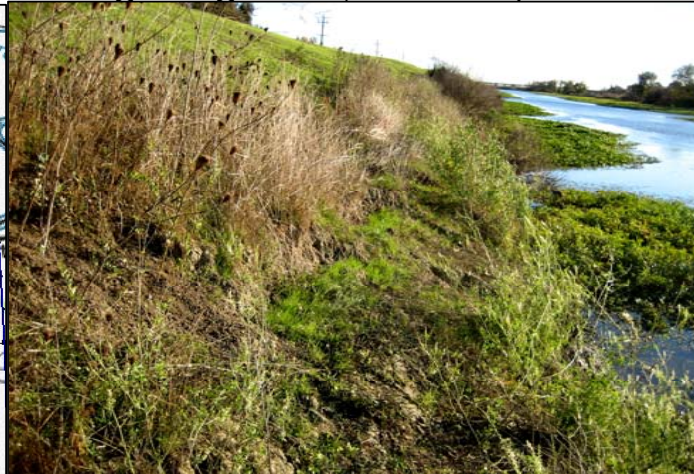
Site Photograph

Knights Landing Ridge Cut, LM 3.0 (KLRD Unit 2 East)

Criteria	Score	Notes
Bank Slope (*2)	2	2:1 slope
Berm Width (*2) - Estimated	5	no berm
Length of erosion	3	1000 ft
Location of erosion	4	toe and lower bank slope
Bank Stability	0	no vertical sections or caves
Radius of Curvature (R_c/w)	0	$R/w = 5.05$
Site Relative to Bend	3	outside of a slight bend
Geomorph	0	no migration possible
Vegetation Cover	0	80% + cover
Tree Hazard	1	young trees
Soil Type (*2)	2	silts with some clays
Velocity (*2)	0	0.11 ft/s
Wave Action (Wind/Boat)	1	occassioanl wave
Economic Factor (*2)	2	town of Knights Landing
Human Usage	1	occassional, no access but near town
Seepage Potential	0	no known seepage history
Tidal Fluctuation	0	no tidal influence
Erosion Hazard	35	Calculate Erosion Hazard

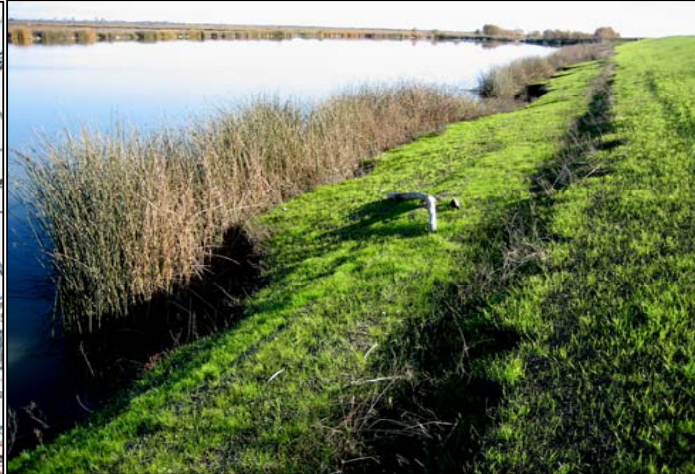
Site Photograph

Yolo Bypass, LM 3.8 (RD 2035 Unit 2 West)

Criteria	Score	Notes
Bank Slope (*2)	0	3:1 slope
Berm Width (*2) - Estimated	5	no berm
Length of erosion	5	1600 ft
Location of erosion	4	toe and lower slope
Bank Stability	2	vertical sections, less than half bank height
Radius of Curvature (R_c/w)	0	straight
Site Relative to Bend	1	straight
Geomorph	0	no migration expected
Vegetation Cover	0	80 to 90 %
Tree Hazard	0	no trees
Soil Type (*2)	2	clays and silts
Velocity (*2)	1	1.5 ft/s
Wave Action (Wind/Boat)	4	heavy wind wave
Economic Factor (*2)	1	Farms
Human Usage	1	occassional
Seepage Potential	0	no known seepage issues
Tidal Fluctuation	0	no tidal influence

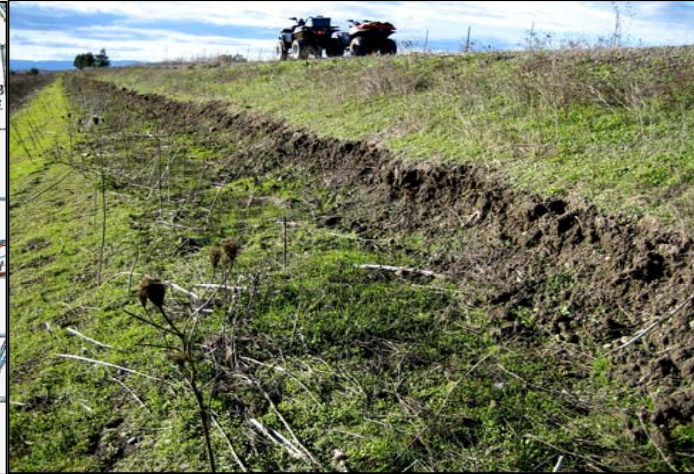
Site Photograph

Willow Slough, LM 2.2 (RD 2035 Unit 3 North)

Criteria	Score	Notes
Bank Slope (*2)	2	2:1 slope
Berm Width (*2) - Estimated	5	no berm
Length of erosion	4	1500 ft
Location of erosion	1	mid levee slope
Bank Stability	2	short vertical sections
Radius of Curvature (R_c/w)	0	straight
Site Relative to Bend	1	straight
Geomorph	0	no migration possible
Vegetation Cover	1	80%
Tree Hazard	0	no trees
Soil Type (*2)	2	slits and clays
Velocity (*2)	0	0.6 ft/s
Wave Action (Wind/Boat)	3	moderate waves
Economic Factor (*2)	1	Farms
Human Usage	2	season, frequent for Duck Hunters
Seepage Potential	0	no known seepage issues
Tidal Fluctuation	0	no tidal influence

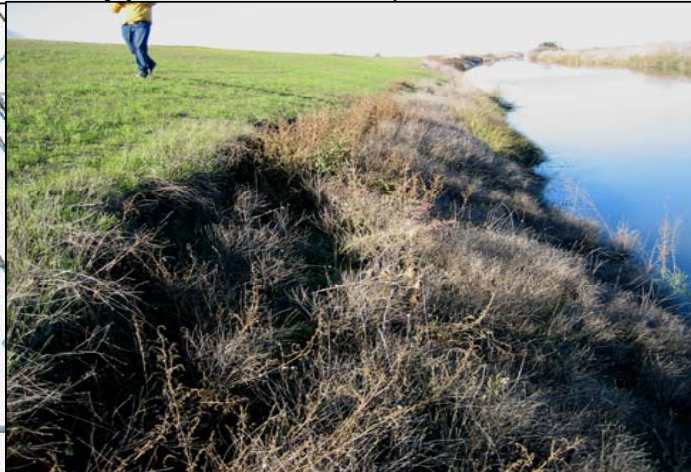
Site Photograph

Yolo Bypass, LM 2.0 (RD 2035 Unit 2 West)

Criteria	Score	Notes
Bank Slope (*2)	0	3:1 slope
Berm Width (*2) - Estimated	5	no berm
Length of erosion	2	275 ft
Location of erosion	4	toe and lower slope
Bank Stability	2	vertical sections, less than half bank height
Radius of Curvature (R_c/w)	0	relatively straight
Site Relative to Bend	1	relatively straight
Geomorph	0	no migration expected
Vegetation Cover	0	90%
Tree Hazard	0	no trees
Soil Type (*2)	2	clays and silts
Velocity (*2)	1	1.5 ft/s
Wave Action (Wind/Boat)	4	heavy wind waves
Economic Factor (*2)	2	Farms
Human Usage	1	occassional
Seepage Potential	0	no known seepage issues
Tidal Fluctuation	0	no tidal influence

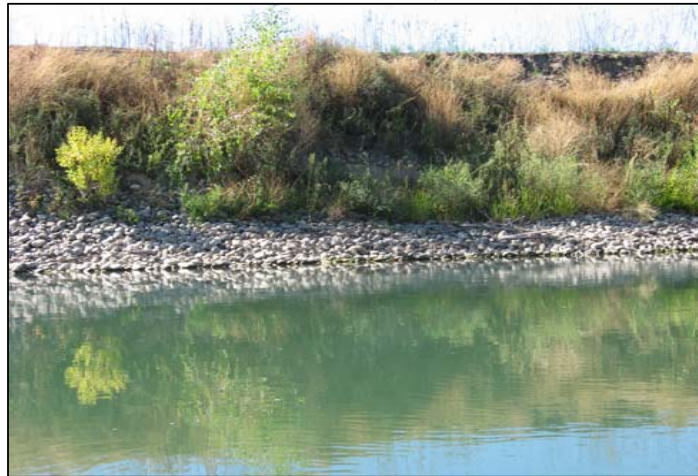
Site Photograph

Sacramento River, RM 133.0L

Criteria	Score	Notes
Bank Slope (*2)	2	2:1 slope
Berm Width (*2) - Estimated	0	30 ft
Length of erosion	4	1069 ft
Location of erosion	2	lower bank
Bank Stability	2	vertical sections less than half bank height
Radius of Curvature (R_c/w)	0	relatively straight
Site Relative to Bend	2	just downstream of a bend
Geomorph	0	no migration expected
Vegetation Cover	2	60%
Tree Hazard	0	no trees
Soil Type (*2)	1	clays and rounded stone
Velocity (*2)	3	4.97 ft/s
Wave Action (Wind/Boat)	3	moderate
Economic Factor (*2)	2	small town of Meridian
Human Usage	2	seasonal
Seepage Potential	0	no seepage history
Tidal Fluctuation	0	no tidal influence
Erosion Hazard	33	Calculate Erosion Hazard

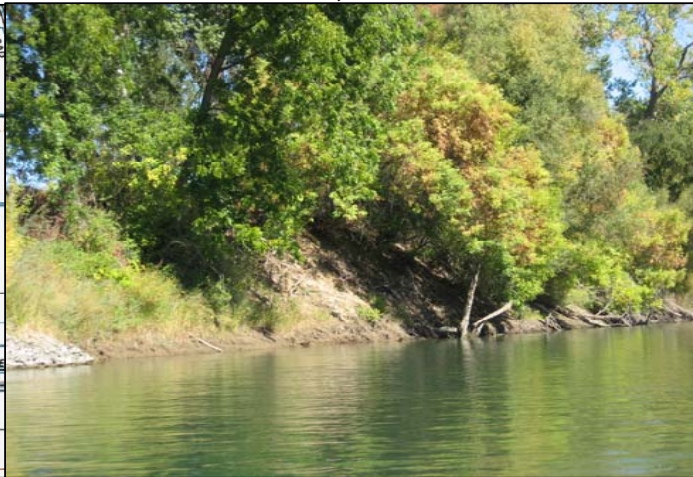
Site Photograph

Sacramento River, RM 123.3L

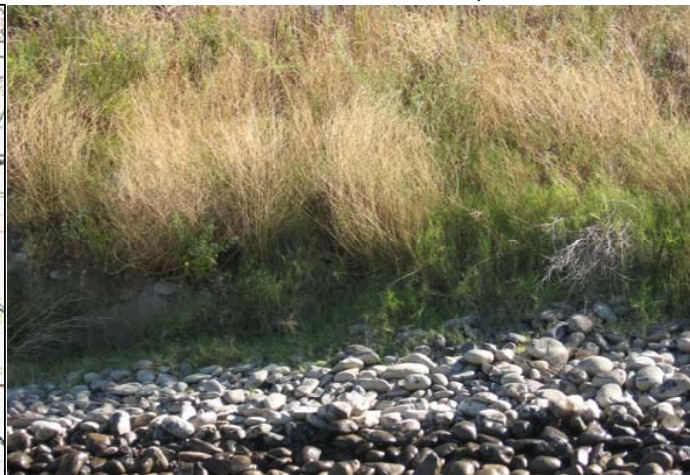
Site Photograph

Sacramento River, RM 136.6L

Criteria	Score	Notes
Bank Slope (*2)	3	1.5:1 slope
Berm Width (*2) - Estimated	0	30 ft
Length of erosion	3	615 ft
Location of erosion	2	lower bank
Bank Stability	0	no vertical sections or caves
Radius of Curvature (R_c/w)	0	straight
Site Relative to Bend	1	straight
Geomorph	0	no migration possible
Vegetation Cover	1	70%
Tree Hazard	0	no trees
Soil Type (*2)	2	clays and silts
Velocity (*2)	3	4.91 ft/s
Wave Action (Wind/Boat)	2	moderate
Economic Factor (*2)	2	small town of Meridian
Human Usage	2	seasonal
Seepage Potential	0	no seepage history
Tidal Fluctuation	0	no tidal influence
Erosion Hazard	31	Calculate Erosion Hazard

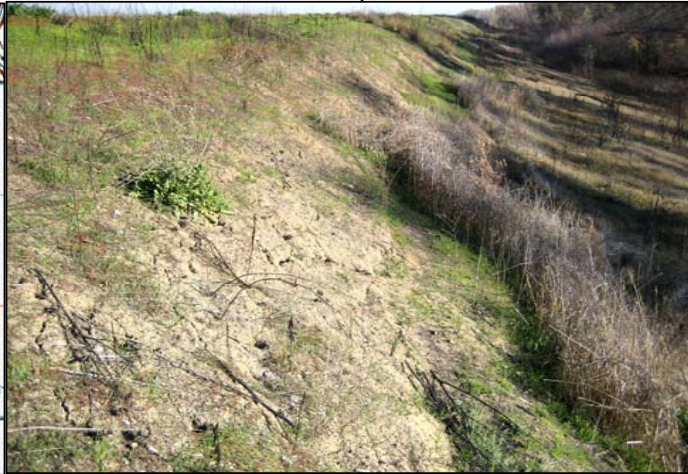
Site Photograph

Natomas Cross Canal, 3.0 (RD 1001 Unit 5 North)

Criteria	Score	Notes
Bank Slope (*2)	3	1.5:1 slope
Berm Width (*2) - Estimated	0	40 ft of berm
Length of erosion	1	100 ft
Location of erosion	4	toe and lower slope
Bank Stability	0	no vertical sections or caves
Radius of Curvature (R_c/w)	0	straight
Site Relative to Bend	1	straight
Geomorph	0	no migration possible
Vegetation Cover	2	50%
Tree Hazard	0	no trees
Soil Type (*2)	2	silts with clays
Velocity (*2)	1	1.5 ft/s
Wave Action (Wind/Boat)	0	no waves
Economic Factor (*2)	2	small town of Verona
Human Usage	1	occassional
Seepage Potential	5	known seepage issues in this area
Tidal Fluctuation	0	no tidal influence

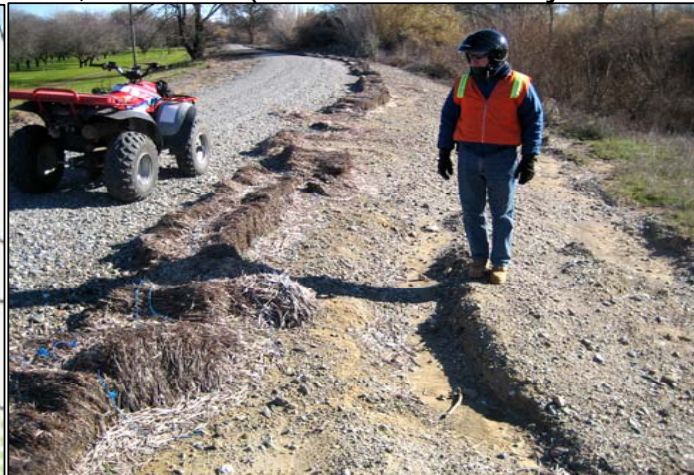
Site Photograph

Elder Creek, LM 4.1 (Tehama County Unit 1 North)

Criteria	Score	Notes
Bank Slope (*2)	2	2:1 slope
Berm Width (*2) - Estimated	2	10 ft
Length of erosion	2	300 ft
Location of erosion	0	upper levee slope
Bank Stability	0	no vertical sections or caves
Radius of Curvature (R_c/w)	0	relatively straight
Site Relative to Bend	1	relatively straight
Geomorph	0	no migration expected
Vegetation Cover	1	minimal in erosion area, 80% coverage on remaining land
Tree Hazard	2	medium trees
Soil Type (*2)	2	clays and gravels
Velocity (*2)	2	3 ft/s
Wave Action (Wind/Boat)	0	no waves
Economic Factor (*2)	2	small town of Gerber
Human Usage	2	seasonal
Seepage Potential	0	no known seepage history
Tidal Fluctuation	0	no tidal influence
